A NEW BIG TOP (How to replace the soft top section of a coach-built roof)

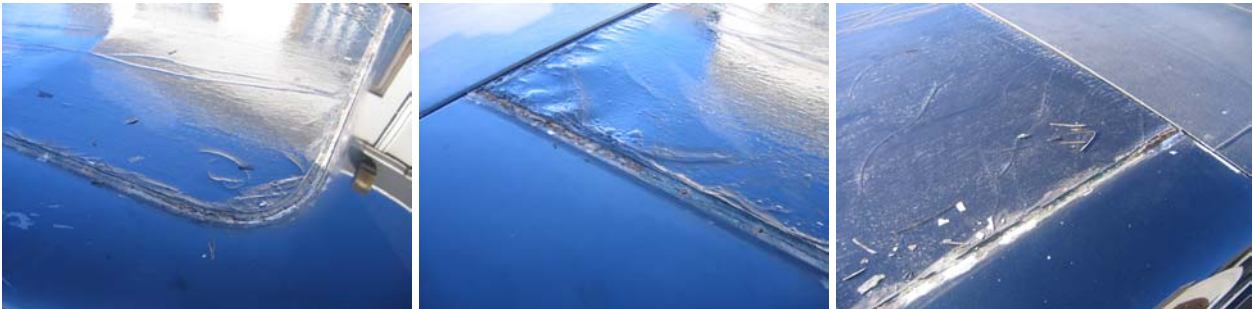
Above with brass strip removed – note deterioration of the leathercloth.

Brass pin beading will probably not be re-useable but can be readily obtained. Our car had brass strip and it was simply a case of find the screws below several layers of paint, dig down to them and unscrew. Because they were brass screwed into wood they were relatively easy to remove. Before removing either type of trim the paint should be scored between the trim and the body to avoid major paint damage to the body. Once removed the outer leathercloth cover can be removed. Take care when doing this and try to remove it in one piece so that it can be used as a template for the new material. I found the tacks to be very rusted and all were removed. A new piece of exterior quality leathercloth sheeting was purchased from Woolies.

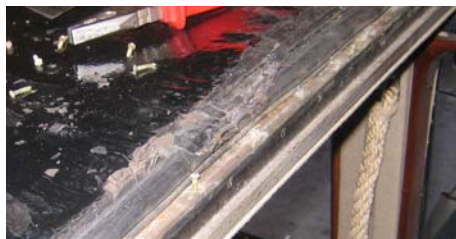
Deterioration was worst at the rear of the roof

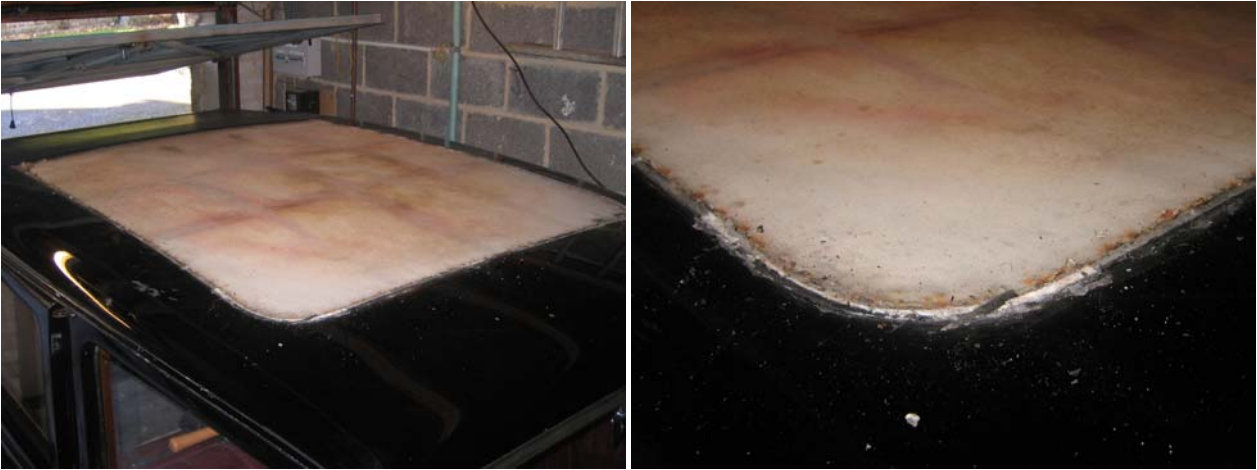
The cotton interface was found to be relatively undamaged despite the amounts of water that must have gone through it but as shown it was badly stained and had come free at one corner where the rain had penetrated most so I decided to replace it.

Cotton was looking a bit tired but sill mainly intact

I bought a piece of crease resistant polycotton curtain lining for this purpose, not that I needed crease resistance but it so happened that this was a heavier quality. The old sheet was removed by removing all the old rusted tacks as above and the piece was then used as a template for the new. Take note of the positions of where these two types of sheeting are tacked, one slightly in front of the other, the cotton being the inner sheet.

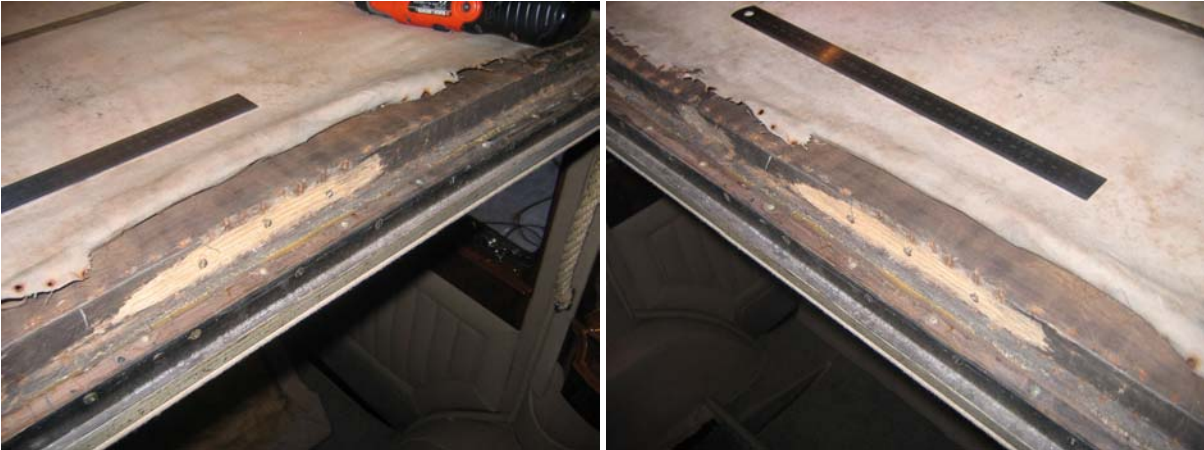
Water had taken it's toll on the woodwork at the back of the roof.

As shown a small area of rot was found on the ash roof cross member where the Landalette hood closes. The wood had turned to a crumbly dust which was removed with a sharp screwdriver and the area thoroughly cleaned. Three small brass screws were screwed in along the affected length so that the flat heads were level with the finished woodwork. This would give the filler strength and give a guide to the finished level when filed and sanded. Marine grade Plastic Padding two part filler was used to repair the damage. This is set in 10 minutes but is best left overnight before filing and sanding.

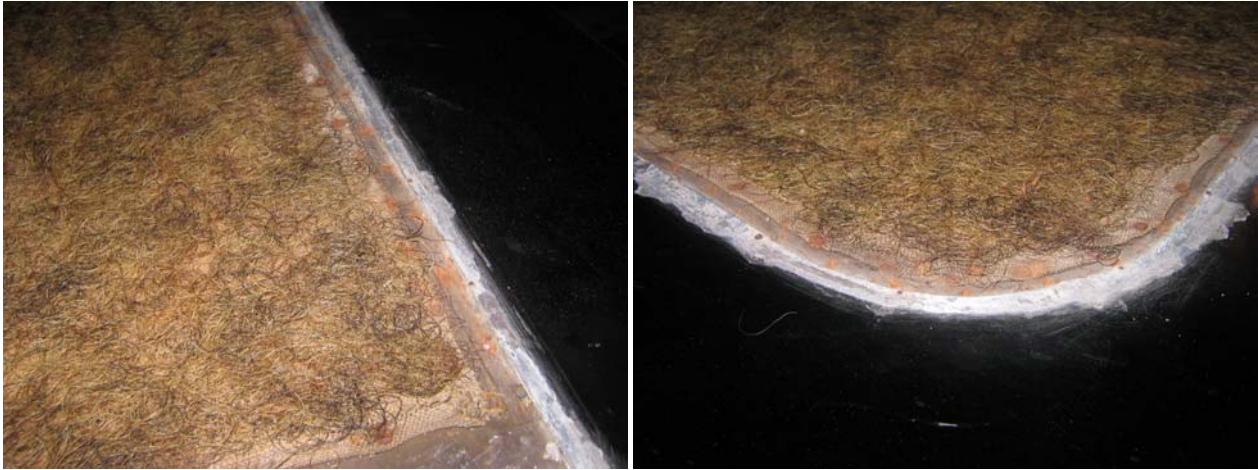
Horsehair and Hessian were in reasonable condition

On our car the horse hair and supporting hessian sheet were in good condition and whilst the tacks were rusted they were sound and so these components were not replaced. But, if any sort of degradation of these are found it's best to replace at this time since it will be a long time before they are exposed again. Horsehair now comes 'rubberised' (Woolies) and is easier to apply since it is in sheet form.

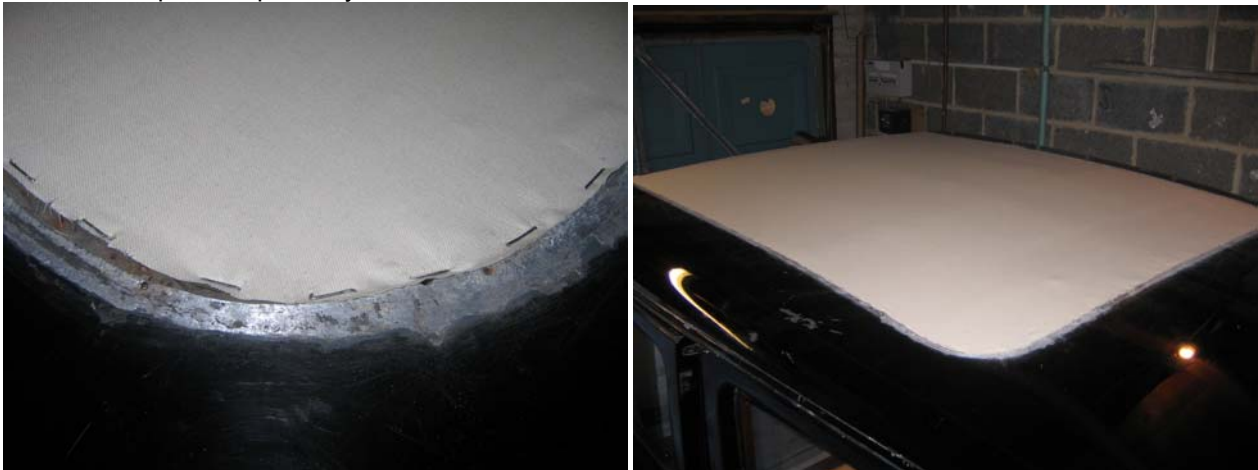
Cotton sheeting should just fall short of the aluminium bodywork. Finished cotton should appear smooth and tight.

At this point the new components can now be assembled. After cutting the cotton sheet to size (add a quarter of an inch – 5 mm oversize to allow for any shrinkage of the original) tack this to the woodwork. If you are a purist you will use tin tacks as the original but I used stainless steel staples for longevity and these were fixed at about 2 inch intervals. Start at one corner with one staple then take tension on the cloth and staple at the other corner on the same side. Then a third staple should be placed at the corner opposite the first staple again taking up the tension on the cloth. Don't stretch the cloth too much since the staples or tacks may tear through the edge of the cotton – just enough to take out the creases. Staple along the longest side with staples about an inch (2 or 3 cm) apart taking tension on the cloth along the way. When you arrive at the corner staple which was put in when started you may have surplus material so remove the staple and re-staple after tensioning cloth. Go back to the corner where you started and staple along the length in the opposite direction repeating the corner process if necessary. Finally staple the remaining two sides tensioning along the way. Trim off with scissors or a new blade in the Stanley knife any excess material. You should finish up with a perfectly smooth cotton cover.

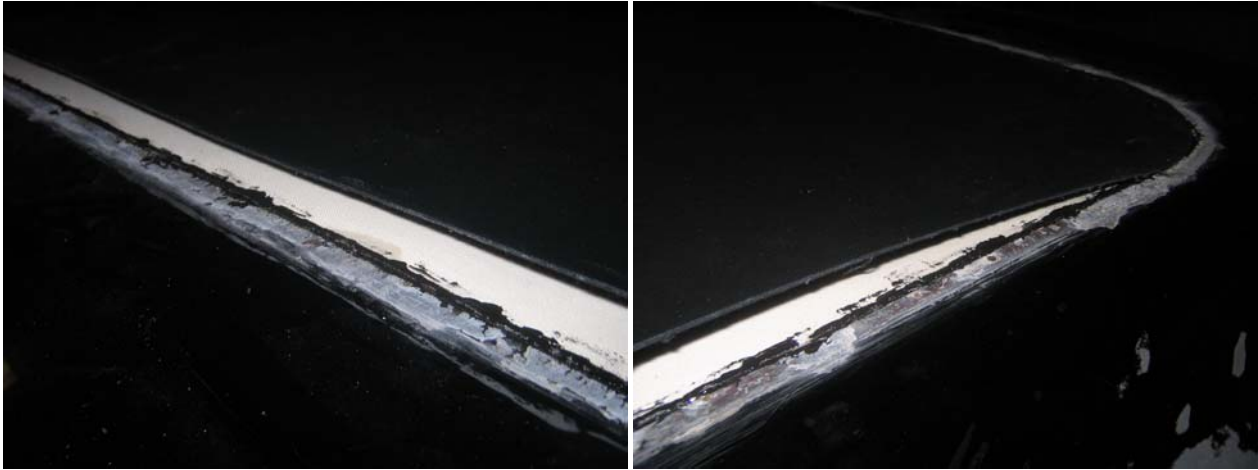
Leathercloth should completely cover cotton and almost meet the aluminium body.

Use the old leathercloth top as a template and cut the new material to size. If the old leathercloth disintegrated or has bits missing it's a good idea to make a template from newspaper or brown paper first and check for fit before cutting out the new material. Place the shaped leathercloth over the cotton and staple to the woodwork as with the cotton making sure that the staples are about a quarter inch (5mm) from the edge. The leathercloth has very little stretch but has enough to ensure that it domes over the top so take up as much tension as it will allow by hand.

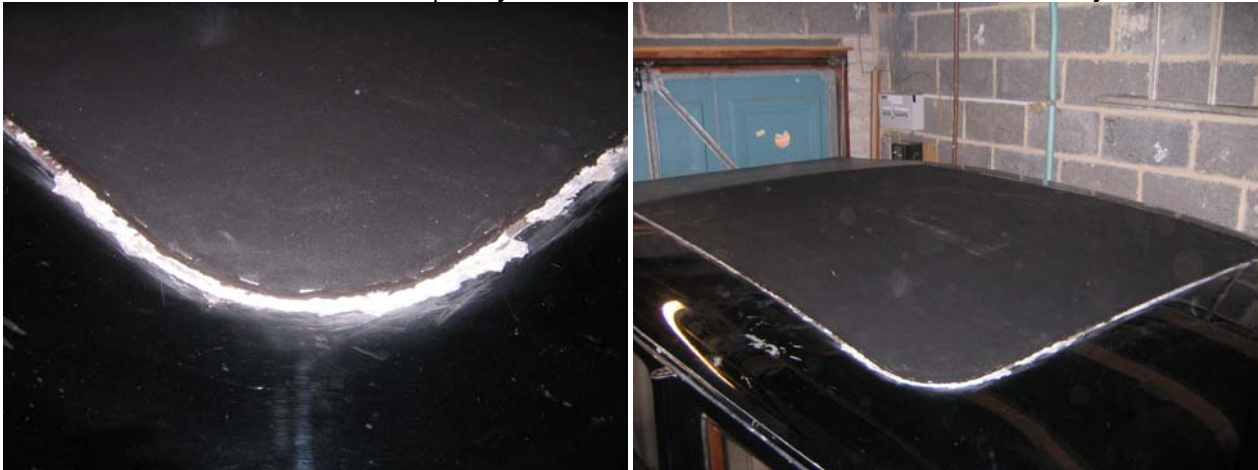
After completely stapling leathercloth

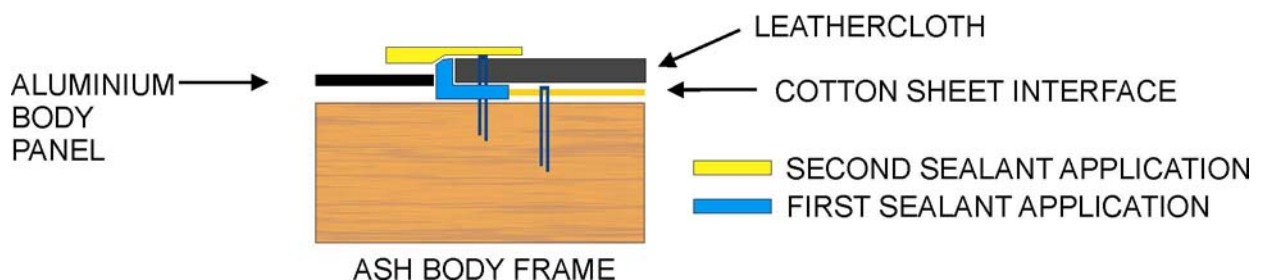
Sealant is applied in 2 stages

Next, sealing the leathercloth to the woodwork and aluminium top which is done in two stages using Sikoflex or Bodyline PU adhesive sealant (Bodyline is Brown Bros own brand equivalent and is about half the price but just as good and was used on my job). This product is an excellent sealer and is much more permanent than normal silicone sealant. There are two main grades. Used professionally the body sealant is used for sealing welded seams on steel bodies and the window sealant is used for bonding windscreens to the steel opening on modern vehicles. I used the body seal grade for this job. However, it takes no prisoners – you must get it right first time. If you've never used it before try it out on a small test piece of leathercloth stapled to a bit of wood. It is an extremely strong adhesive and sealant, if you get it on your hands and don't remove it immediately with white spirit or thinners it will be there for a week. If you have any sort of skin allergy, use protective gloves but these can be a problem if they are rubber or latex since the sealant will bond to them. Less convenient are polythene gloves but they will work. Remove it from paintwork using white spirit only. It has a very short shelf life – typically 6 months, and will cure inside the cartridge. However when it does don't throw it away – you can saw through it and use for bushing as you would with rubber. It comes in a cartridge and is applied using a standard sealant gun. First, apply a small bead of sealant underneath the quarter inch gap at the edge of the leathercloth then another small bead into the gap between the leathercloth and aluminium body and smooth level with a plastic or wooden spatula. After you have gone around the whole roof you can, if required, make the sealant smooth by dipping a finger into a strong solution of washing-up liquid and smoothing as you would with silicone sealant. Leave overnight to cure.

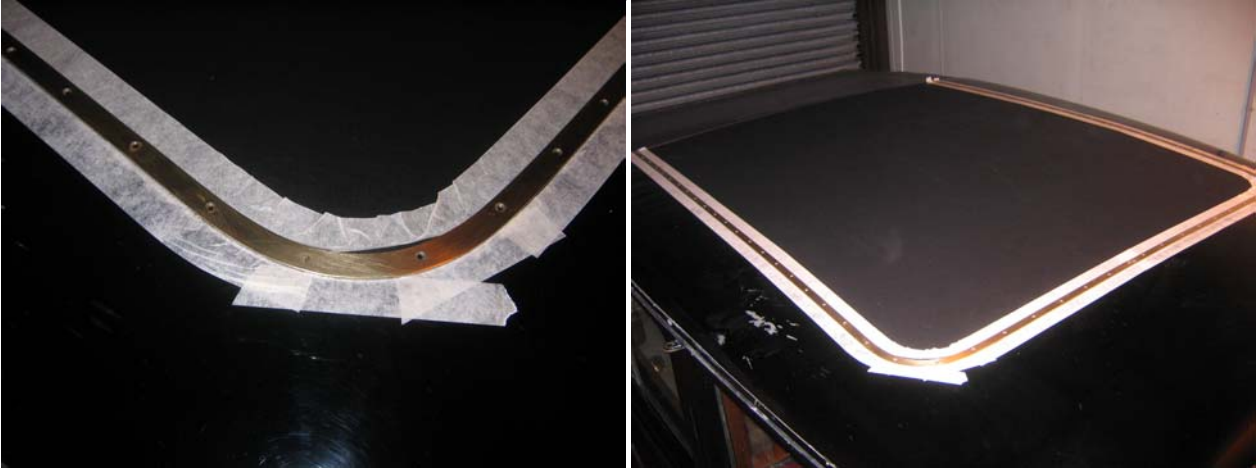
Taping up to create the final seal

The second part of the sealing process will make a seal which is the width of trim bead and cover the whole joint between leathercloth and body. Place the brass trim strip in place on the roof and hold in place with 3 or 4 screws. Using masking tape, tape either side of the strip so that when the strip is removed you have a gap representing where the strip will fit. This procedure will be more difficult if you are using pin bead since you cannot lay it in place and effectively tape so you may have to tape up by measurement. Apply Sikaflex to the gap and smooth to a depth of about 2 to 3 mm overlapping onto the masking tape. After applying around the roof immediately remove the masking tape to reveal the new seal. It is important that you do this before the Sikaflex cures since when it has you will remove some of the seal or not be able to remove the tape. Gently removing the masking tape should leave an neat edge. Again leave overnight to cure.

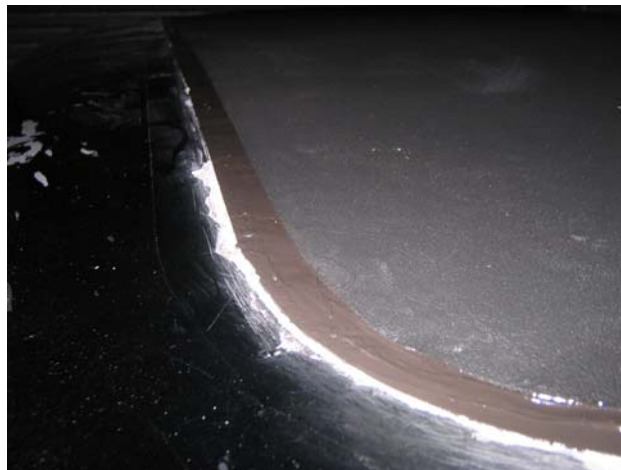
Final seal after removing masking.

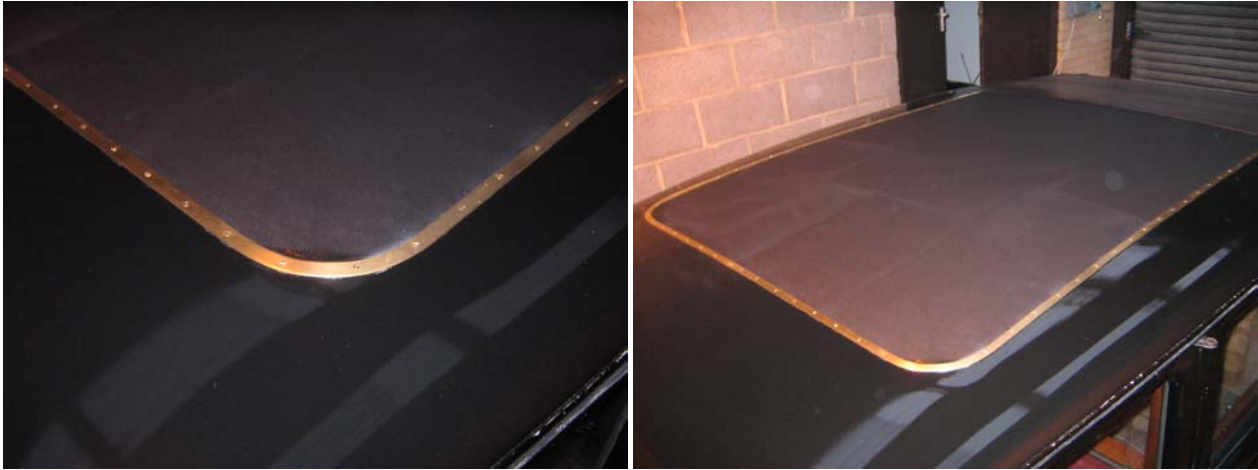
After re-paint - job finished!

All that remains is re-fit the brass strip (after removing any old paint and repainting if needed – I prefer to see the bare brass even when weathered).
