The 1936-2003 history of a museum vehicle

# Rolls-Royce 25/30HP 2D Fixed Head Coupe

Year of manufacture: 1936  
Chassis number: GUL80  
Engine number: P27M  
Coachbuilder: J.Gurney Nutting & Co. Ltd  
Original registration: EYX-366 /England  
Finnish Registration: RR-36 / Finland, September 19<sup>th</sup> 2002

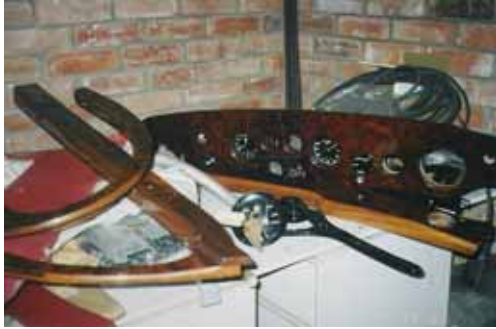
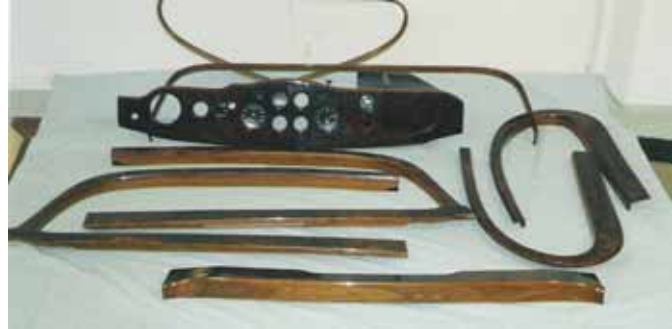
Interior wood parts as seen in a barn in Essex 2001, and Tapiola 2002

In February 1984, Mr. Cole had had the interior woodpaneling and dashboard made by Donald R. Steinert in Grants Pass, Oregon, USA. Steinert is a RR certified manufacturer of wooden parts and also makes Grand Pianos.

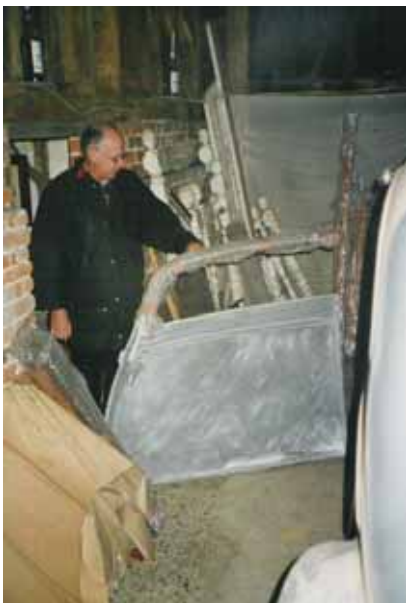
Right hand door, or what is left of it. Presented by the person who sold the car to me, Douglas “Doug” Nixon, a life long Rolls-Royce enthusiast who with his son still arrange wedding etc. rides,.

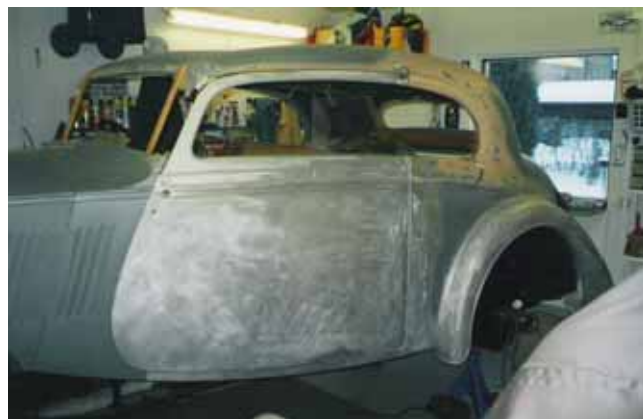
Left hand door in its proper place, wooden sticks acts as A-pillars.

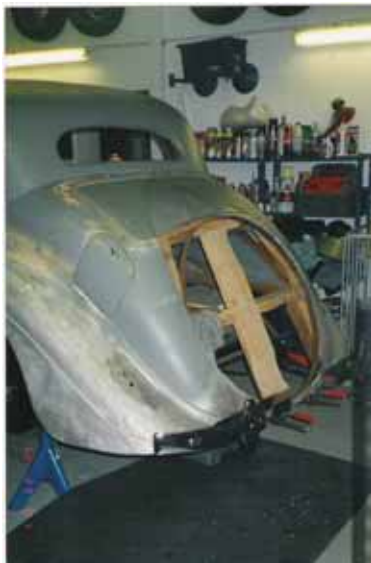
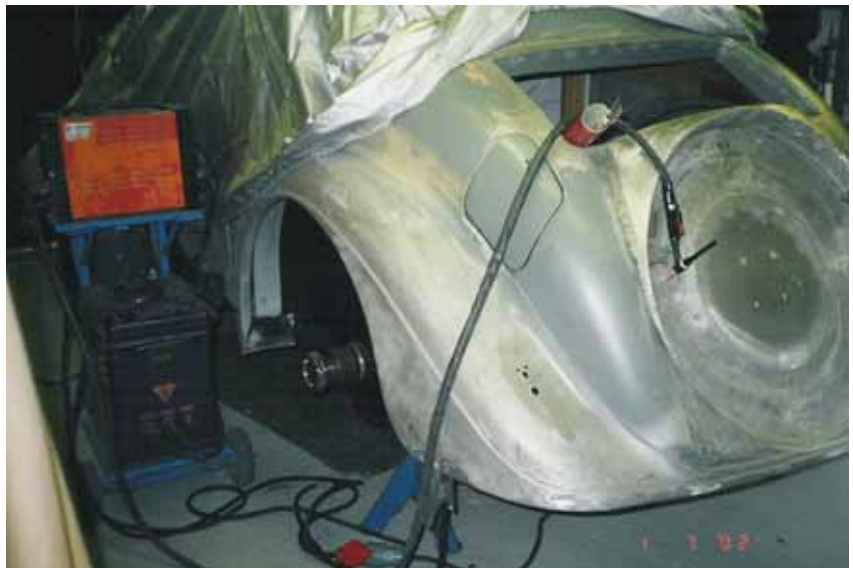
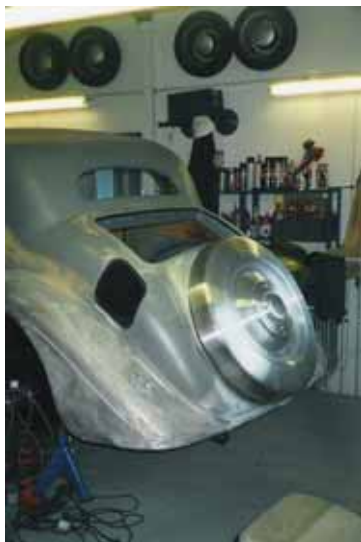
The spare tyre compartment bottom part, which was completely off, here welded back on. The completely missing spare tyre compartment cover was made according to a template by Spinning Lathe Workshop Johansson in Helsinki..

After this I was only missing the spare tyre cover, which had been missing when I received the car. Apparently it was lost in one of its earlier moves. Based on photographs and the profile of the spare tyre, I had a template made of the profile of the cover. Johansson's Spinning Lathe Workshop made a really good cover from 1.5mm aluminum sheeting. After I made the locking handle out of stainless steel for the cover, tear drop shaped like the door and petrol tank handles, and the outer ring around it, the rear end was ready for priming and painting.

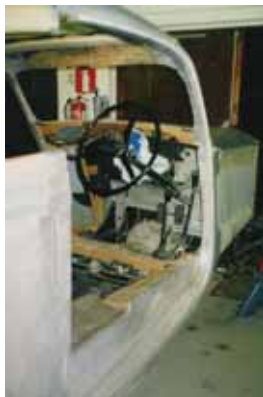
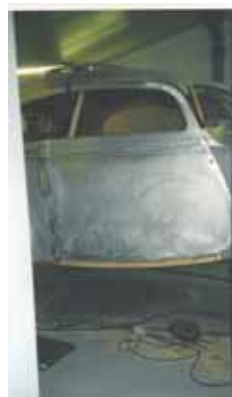
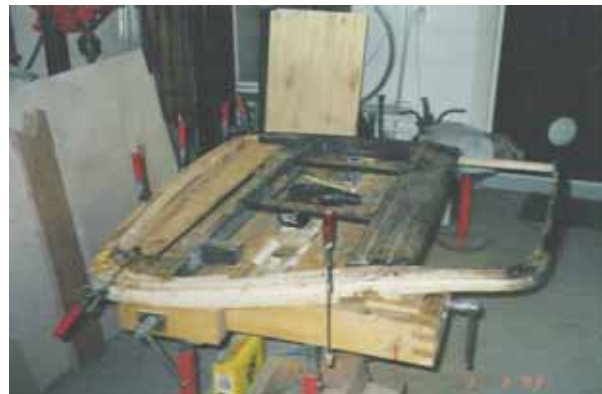
The making of the framework of the right hand door, its frames and fitting in place.

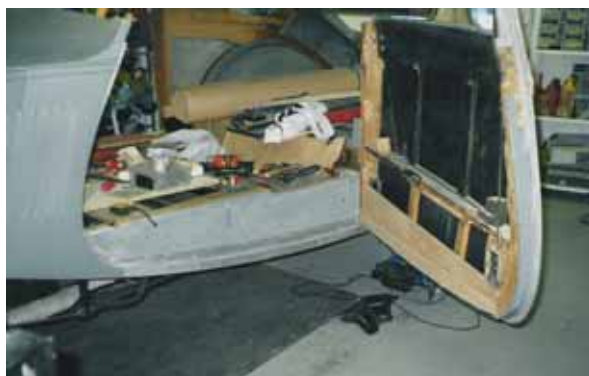
The left sill welded ready

Finally when the door was in place, it was time for the door sill and its sheet plating. This plating was pretty interesting to do as well. The sheeting has to have a specific curve in two directions and it has, within some 20mm four 90 degree bends. But after enough practice and a couple models, it worked out. Then on to the right side door: This turned out to be a real challenge as there was practically nothing left of the door, just the sheeting and some badly rotted and pulverized parts of the wooden framework. The only thing to do was to look at the opposite side door and try to copy the framework, as much as was visible, as the side and outer sheeting was already in place. When I measured the left side door to get dimensions to make the parts, I soon realized that the two doors were clearly different size. Even though the chassis was made by Rolls-Royce the marks of “one of a kind” handiwork was evident. On the other hand, in the case of the doors, it doesn't matter. Even if one needs a new door, it will in any case be made to order, absolutely no chance that RR would carry in stock spare parts like this. With the aid of the outer sheet and inner panel I was able to make the framework to its correct size, machine the recesses for the lock and hinges and fit them in place. Also I had to fit the door window with “sliding strips” and lifting mechanism. Then it was the matter of attaching the steel edging guides with wood screws onto the framework. Then it was the making of the side sheet”. After this I could bend the outer sheet around the “steel edging guides and side sheeting. Now finally the construction showed a strong resemblance of a door. The lack of the B-Pillar (Pillarless coupe) makes the handling of the door difficult and it feels “soggy”, until it is on its hinges. The “window frame” is actually just a hinged beam that is loose/free until it is attached onto the roof. This is then followed by fitting of the door to the body of the car, making of the hinge beam, its sheeting, and the making of the door sill just as I had practiced with the left side door previously.

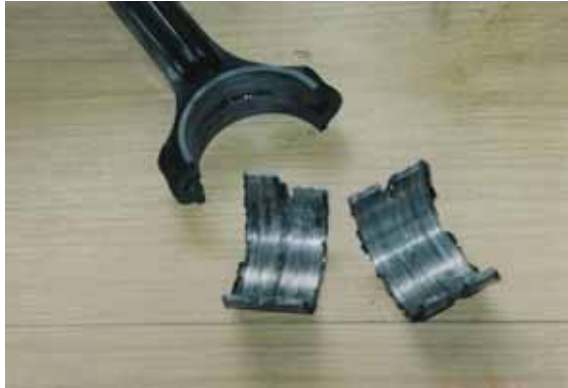
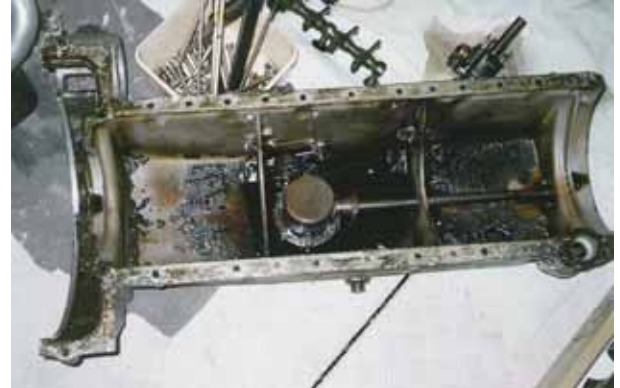
Spring of 2003, on the way to Borgvik of Siuntio to an old cars gathering, loud knocking, which increased in intensity, compounded with the loss of oil pressure forced me to abandon the trip and have the car towed back to the garage. The damage was in the lower bearing of the 5<sup>th</sup> cylinder connecting rod . At first I believed I could fix it from the oilpan side , but when I saw what was inside the oil pan, and the poor state the neck of the crankshaft , I opened up a couple other connecting rod bearings and realized I had to do a much larger repair , even if it was in the middle of the prime driving season.

The lower bearing of the 5<sup>th</sup> cylinder connecting rod and oil sump removed

After I had taken the engine apart, I realized that the 5<sup>th</sup> cylinder had been a problem before, because it had a different connectingrod than the other pistons. It was not “diamond grinding ” shape like the others , the cross-section of the connecting rod at the oil channel of the upper bearing was round. In addition the lower end bearing had no oil hole. Book by R.Haynes and M.A. Grigsby “*Rolls-Royce Small Horsepower Engines*” – 1977 was a great help in the process of taking the engine apart. It had listed all the types of threads, the direction of the threads, the required dimensions and thread information of specialized tools like pullers . Without the information in this book I probably would not have been able to take the engine apart without damaging it. Especially notable is the time when I first had to build up by welding one tooth of the feeding gear of my home workshop lathe before I could make left hand inside English pitch thread to the crankshaft damper puller. I was very sceptical myself when starting but finally it proved to be a very operational puller afteral.

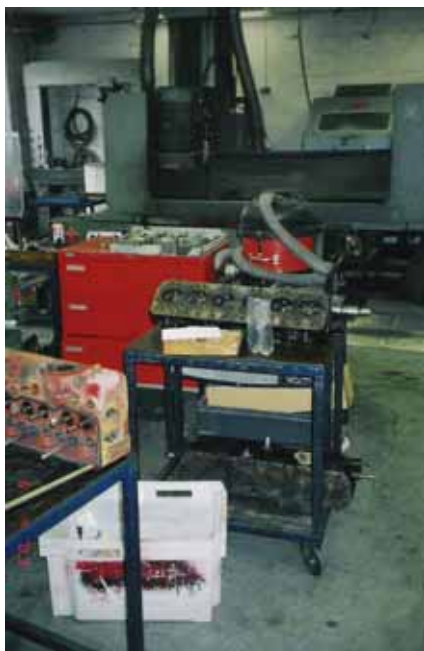
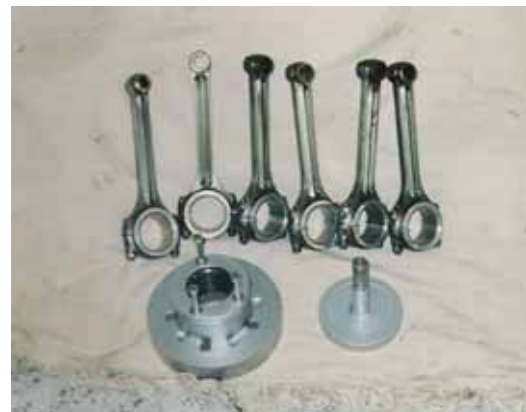
Connecting rods with new bearings waiting for engine assy. At the bottom home made fixtures to make sure that white metal bearings at the both ends of connecting rods were machined parallelly .

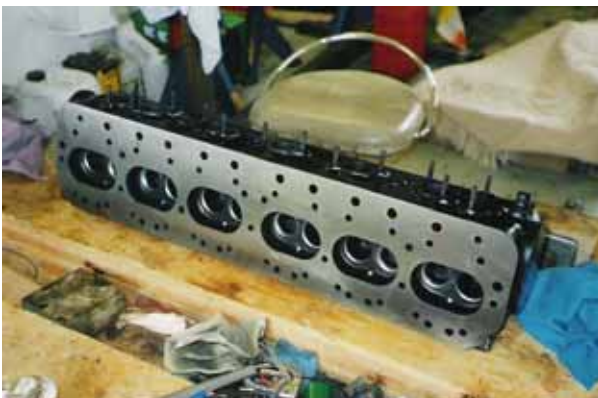
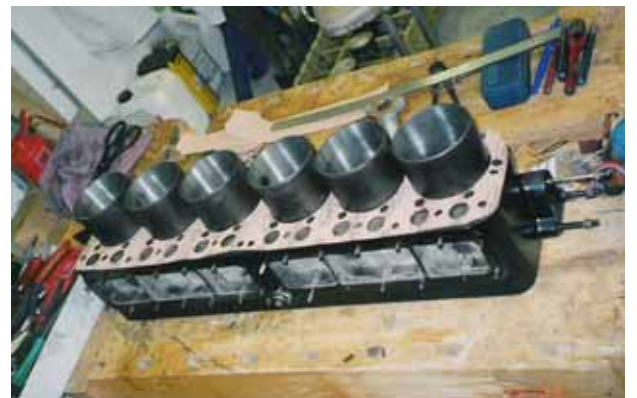
Head, and cylinder group after machining

In this image the water channels in the cylinder group and cylinderhead are clearly visible. RR recommends to block the three forward pairs, because the inherent flaw of the engine is that aft portion of the cylinder group runs hot. I did not do this, instead I added a small electric driven water pump in the circulation system (27 l/min) which injects water towards the rear. According to an infrared thermometer, I was able to achieve the same end result without decreasing water circulation in the forward portion, which would have been the case had I done otherwise.

The cylinder block, crankshaft and cylinder head prepared for reconditioning at Lohjan moottorikoneistamo. The cylinders were not visibly worn and had only small marks of corrosion due to long term storage. The cylinders had been machined to the maximum oversize earlier, so this time they were just honed and new pistonrings were mounted. New valve seats were prepared for all exhaust valves.

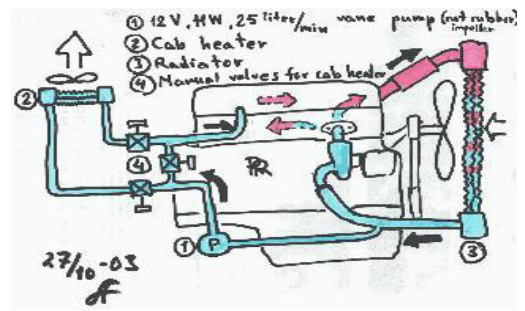
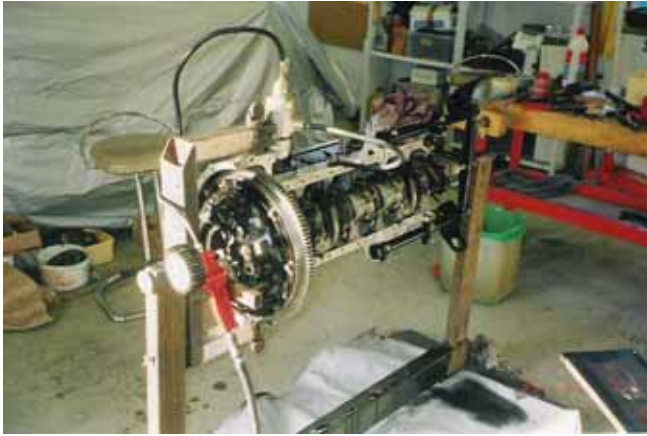
Schematics of the cooling system, with the additional pump. The pump is located inside the chassis beam, so that it is not visible unless viewed from under.

Due to the large size of the engine. I made a handling rack, where the assembly and handling in general would be easier and safer! Here is the test pressurization of the oil channels (with pressurized oil) before the final assembly of the engine.

New bearings for the timing gears and oil plugs for the crankshaft journal drillings, machined by "Turning shop Lehtola" in Karjaa. The old plugs had 'evaporated' due to oxidation due to the years of accumulation of oil sludge..
