A NEW BIG TOP (How to replace the soft top section of a coach-built roof)

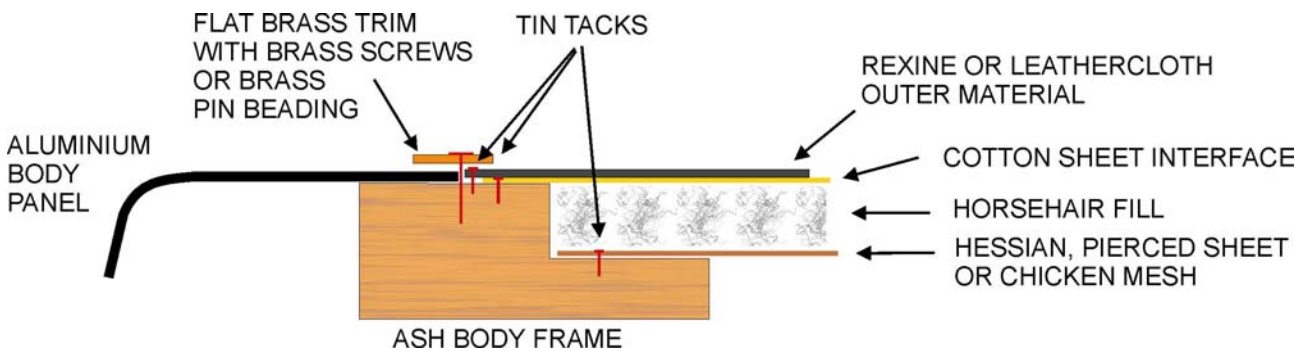
The next illustration shows a section through the roof and how this is made up.

As shown the trim covering the join between the fabric section and the aluminium body is either a flat brass strip secured with brass screws or half round brass beading with integrated pins and this is the first to be removed.

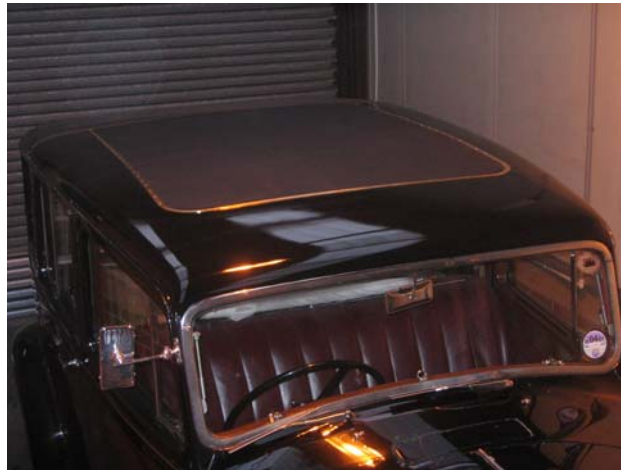
Stand back and admire.

Test the watertightness of the roof by hosing plenty of water onto the roof with a pressure at least as hard as heavy rain. With brass strip which is screwed to the roof there can be water ingress via the screw holes. If this happens remove the screws in the affected area and refit with a small quantity of Sikaflex on the screw threads. As a belt and braces exercise you could also run a small bead of Sikaflex around both sides of the trim but this will make removing the trim at some later stage difficult and prone to damage of the surrounding paintwork on one side and the leathercloth on the other.
